Manhole Inspection Summary

Manhole # S43M__025MH

Insp Date: **5/18/09 8:44 AM**

Location Address: **1641 LANCASTER ST**

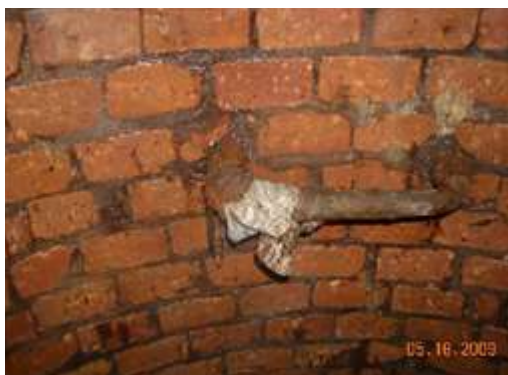
Defect 3

Count: **8** Missing: **1** ☒ **Corroded**

☒ **Evidence Of Surcharge** Depth: **4** (ft.) ☐ Active Surcharge Present

EVIDENCE OF SURCHARGE & corroded steps

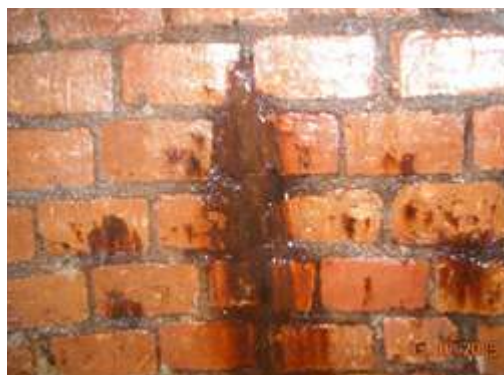
Defect 2

Infiltration: ☐ None ☐ Joint ☐ Cracks ☐ Mortar ☐ Roots ☒ **Wall**

INFILTRATION STAINS

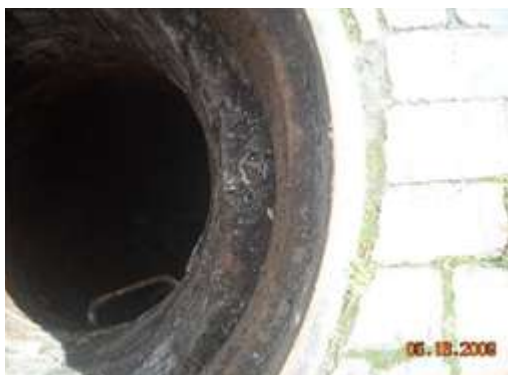
Defect 1

Offset: **2** (in.)

FRAME OFFSET

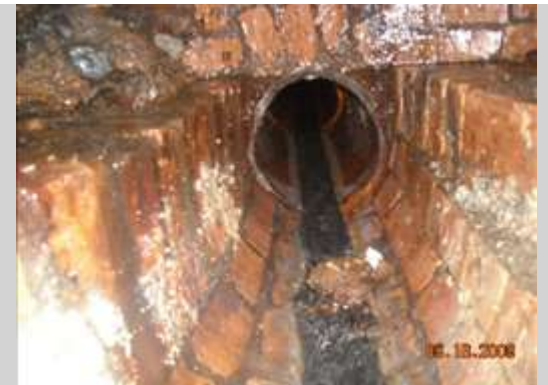
4 O'Clock Inflow

Pipe Height: **8.4** (in.) Rod and Bar (Angled)
Pipe Material: **Clay** ☐ Pipe Lined
Invert Depth: **11.56** (ft.) Flow Characteristics: **Slow**
Deposits: ☐ None ☐ Mud ☐ Sludge ☒ **Debris** ☐ Grease
Silt Depth: **1** (in.) Deposits Extent: **Light**
Infiltration: **None** Pipe Seal Cond: **Sound**

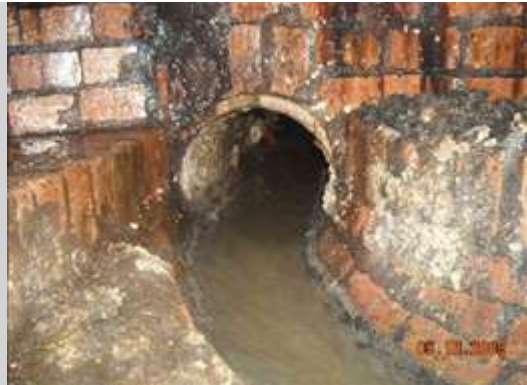
7 O'Clock Inflow

Infiltration: **Evidence** Pipe Seal Cond: **Sound**
